November 15, 1962

REPORT OF TEST ACTIVITIES - NON-VACUUM WINDOWONE-4091
COPY 1 OF 2
STAT

22 OCT. 62 - 5 NOV. 62

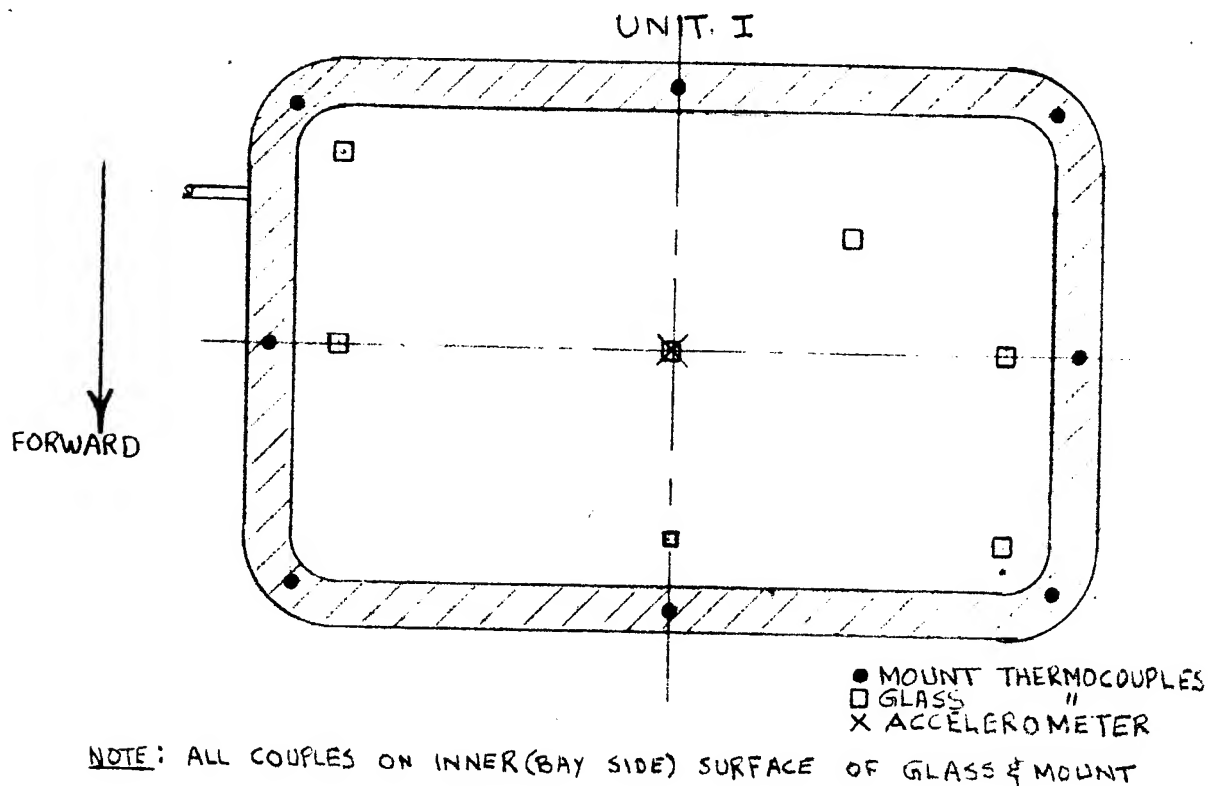
THERMOCOUPLE LOCATION

Unit No. 1 was instrumented as shown in Figure 1. In addition to the

thermocouples shown, additional thermocouples were placed:

1. Between skin and mount in right forward corner of unit #1
2. On inner surface of skin at center of hatch
3. In center of bay approximately 6" above skin

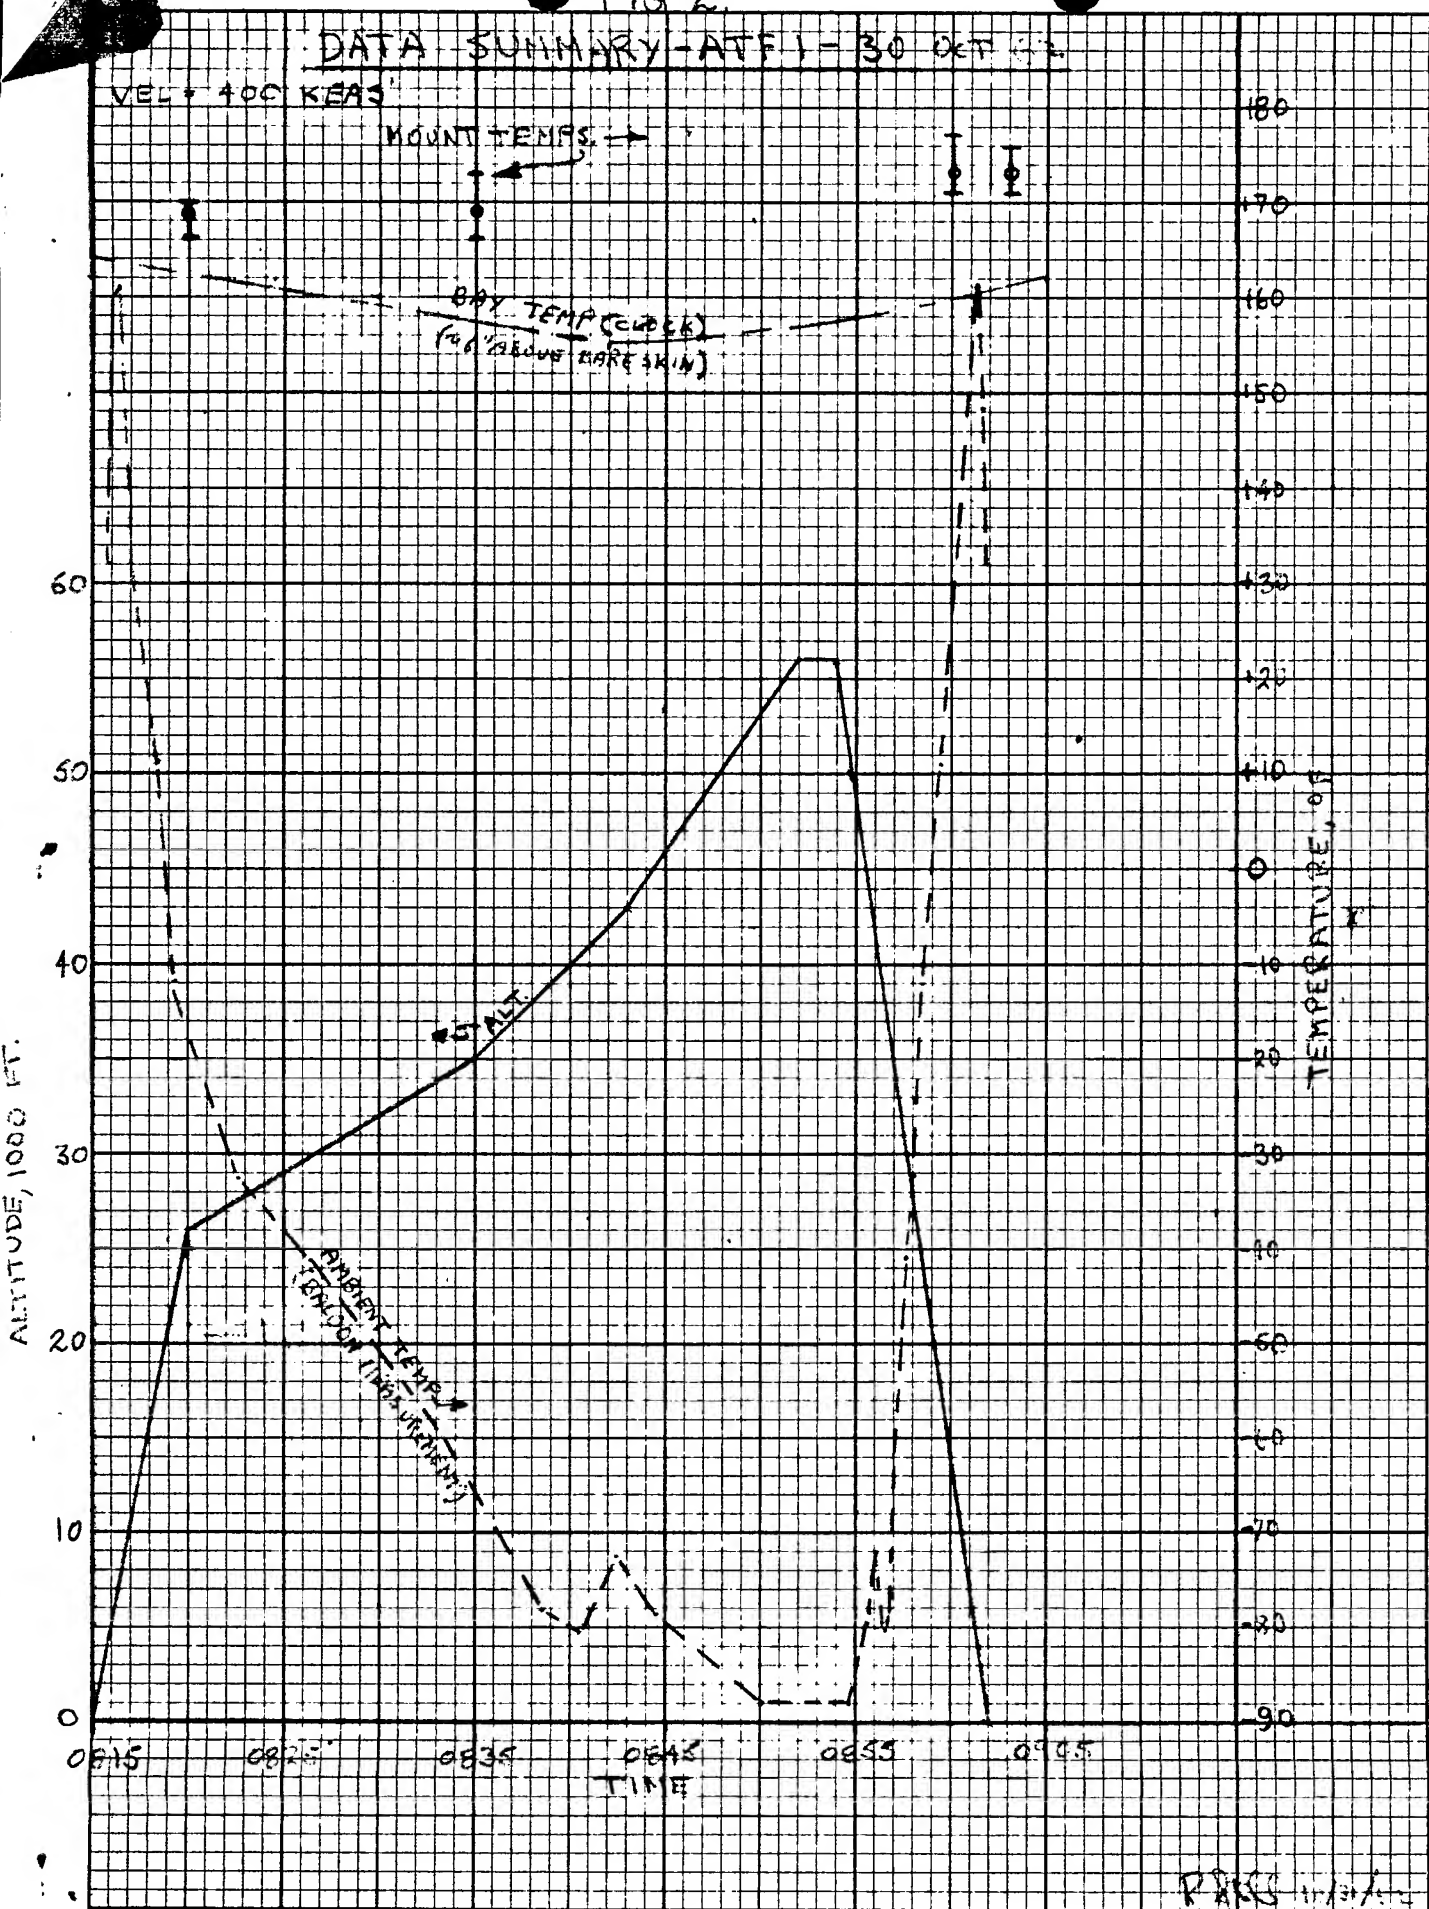
FIG 2

As regards the test data itself, one recorder did not function for ATF 1 due to the accidental breakage of a wire during hatch installation. Therefore, glass temperatures and vibration data were not obtained for this test. For ATF 3, the vehicle operator failed to report the times at which he actuated the recording equipment and although the data is presented in Figure 4, the times at which these data were obtained is unknown.

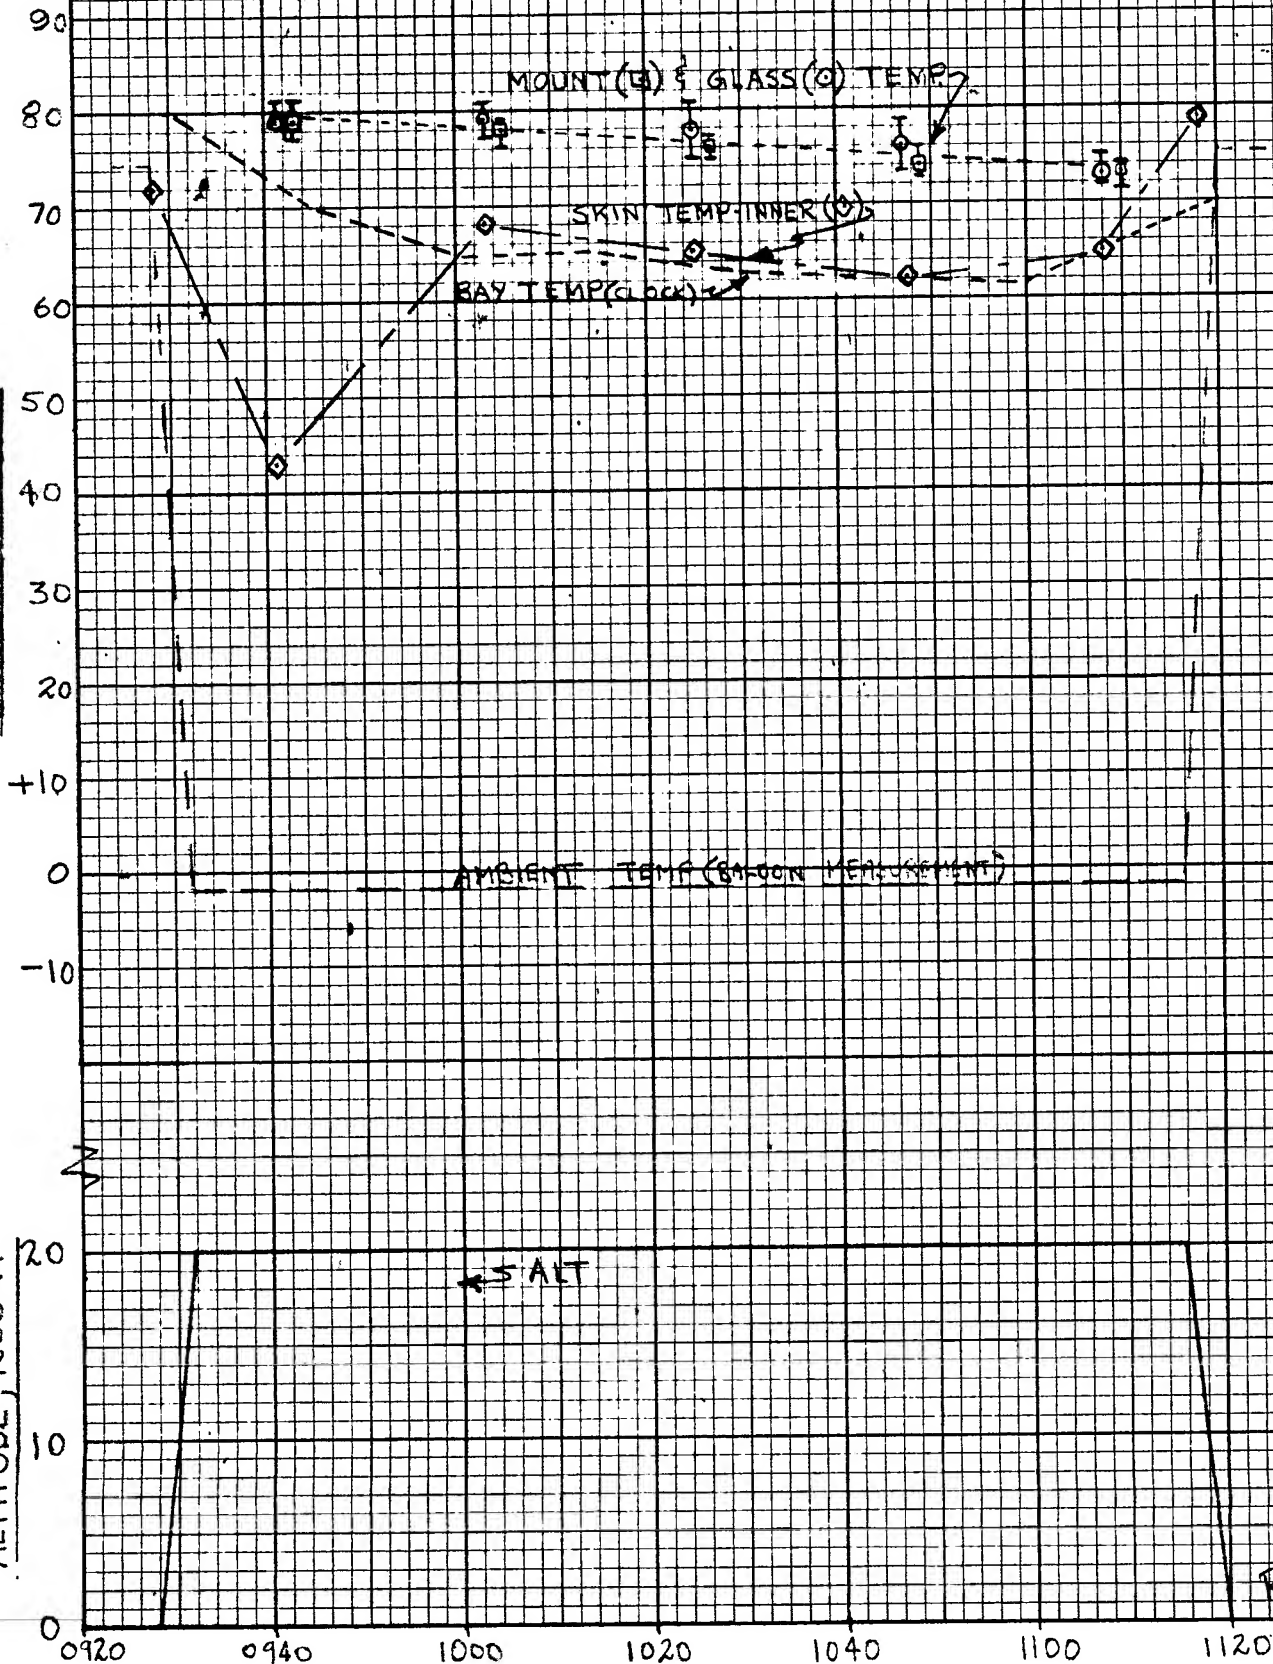
FIG 3

As an example, consider the data of ATF 2 (Figure 3). At approximately 1110 hrs., mount and glass temperatures were 73°F and bay temperature was 78°F. Calculation of expected skin temperature yields a value of 68°F which is almost identical to the measured skin temperature of 65°F. However, the total differential being but 8°F, an error of only 2°F would result in a 25% error in calculation. Moreover, the calculated effect of the total possible change in mount temperature which could result from our changing mount spacers is but 6°F as opposed to an expected 60°F for design conditions.

For ATF2(Figure 3) all equipment functioned properly; and flight parameters (constant altitude and speed, 2 hour duration) were the best of the three flights for approaching steady state conditions. It is felt, therefore, that the data of this test is the most useful as regards thermal characteristics. Figure 3 shows that measured mount and glass average temperatures are within 2°F of each other, and that the maximum spread is $\pm 3^\circ\text{F}$ which is well within estimated accuracy limits of $\pm 5^\circ\text{F}$. Calculated overall heat transfer is of the order of 5 BTU/ft²-HR and calculated inner skin temperature is 68°F versus measured values of 62°F-65°F during the latter portion of the mission. At a mach no. of 0.85 the temperature ratio of total temperature to ambient temperature is 1.142. Assuming outer skin (and glass) temperature of 60°F, the calculated ram rise recovery is 95% which seems rather high. Vehicle People estimate ram rise recovery at approximately 80% based on skin temperature measurements at the upper hatch. This would yield an outer skin temperature for ATF 2 of 50°F.
